AIRCRAFT ACCIDENT REPORT 3/2009

Air Accidents Investigation Branch

**Report on the serious incident to
Boeing 737-3Q8, registration G-THOF
on approach to Runway 26
Bournemouth Airport, Hampshire
on 23 September 2007**

Aircraft Accident Report No: 3/2009 (EW/C2007/09/12)

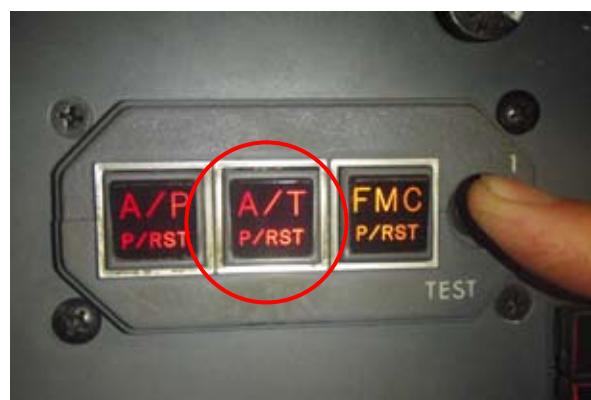
Figure 2
Autothrottle red warning of disengagement

It is recommended that Boeing, in conjunction with the Federal Aviation Administration, conduct a study of the efficacy of the Boeing 737-300/400/500 autothrottle warning system and if necessary take steps to improve crew alerting. (**Safety Recommendation 2009-043**)

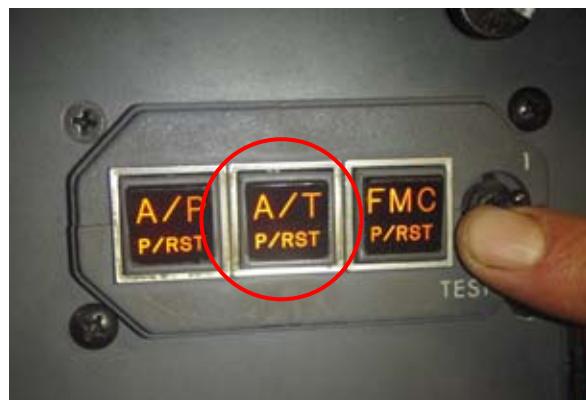
Figure 3

The AT/WARN autoflight status annunciator will illuminate with a flashing amber light (Figure 3) if the autothrottle is not holding the target speed. There are three conditions when this light will flash; the airspeed is 10 kt above the target speed and not decreasing, the airspeed is 5 kt below the target speed and not increasing, or the airspeed has dropped to alpha floor (a factor of 1.3 above the stall speed) during a dual channel autopilot approach. On approach, with the aircraft decelerating, the caption will routinely flash for extended periods.

Autothrottle amber off speed caution

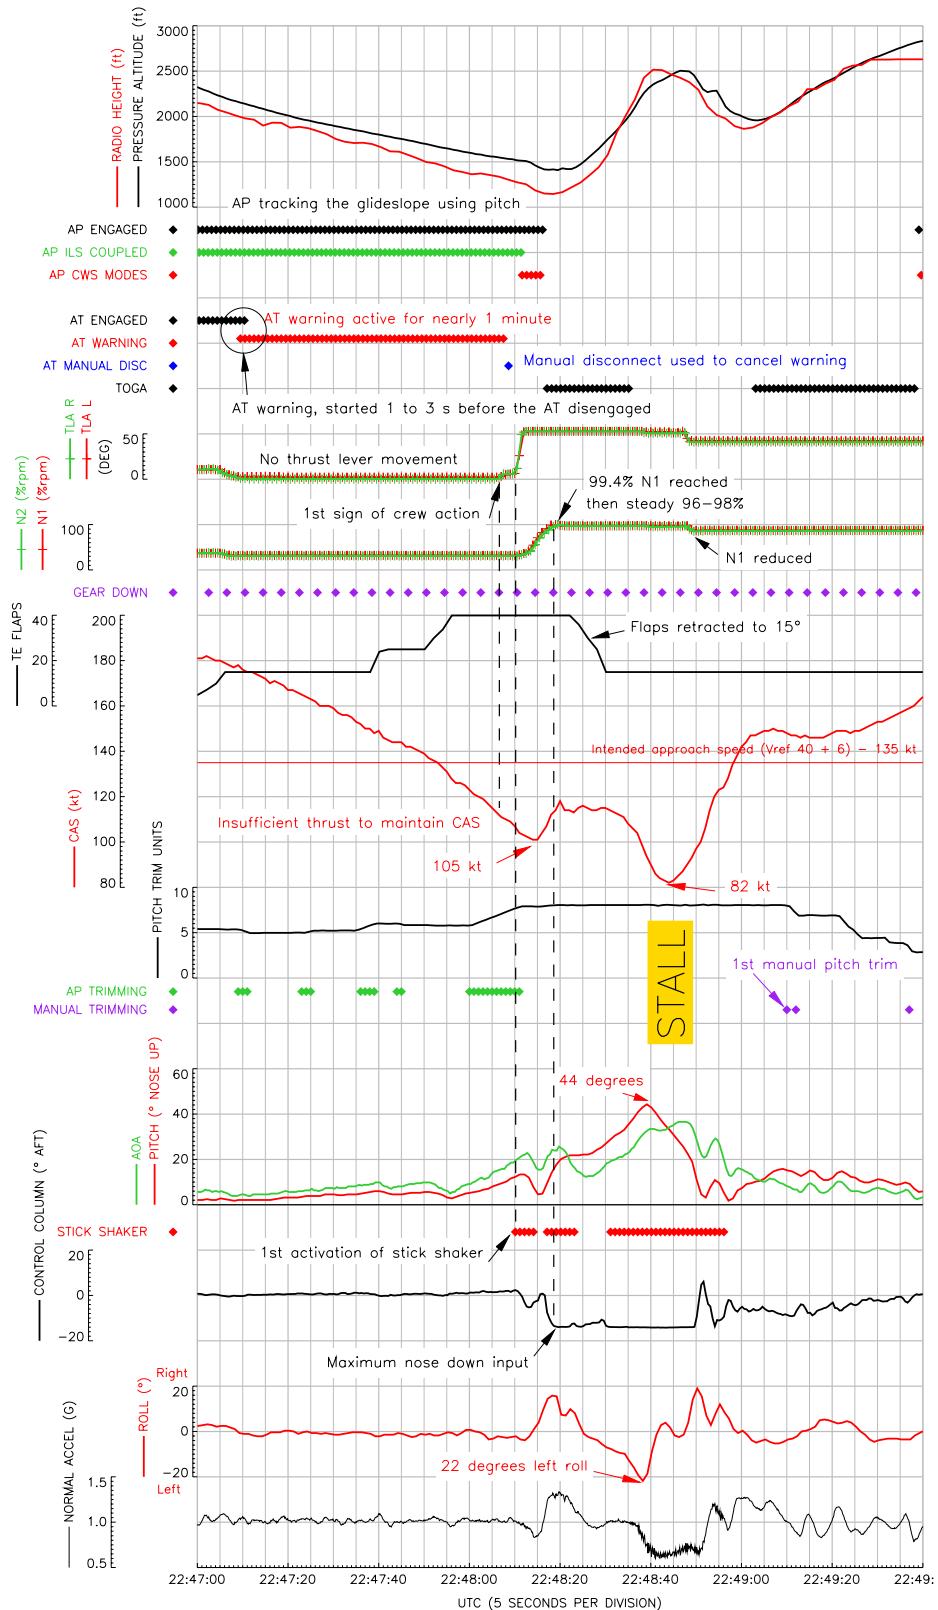
Figure 4
Quick Access Recorder data depicting the accident
