FINAL
KNKT.14.12.29.04

Aircraft Accident Investigation Report

**PT. Indonesia Air Asia
Airbus A320-216; PK-AXC
Karimata Strait
Coordinate 3°37'19"S - 109°42'41"E
Republic of Indonesia
28 December 2014**

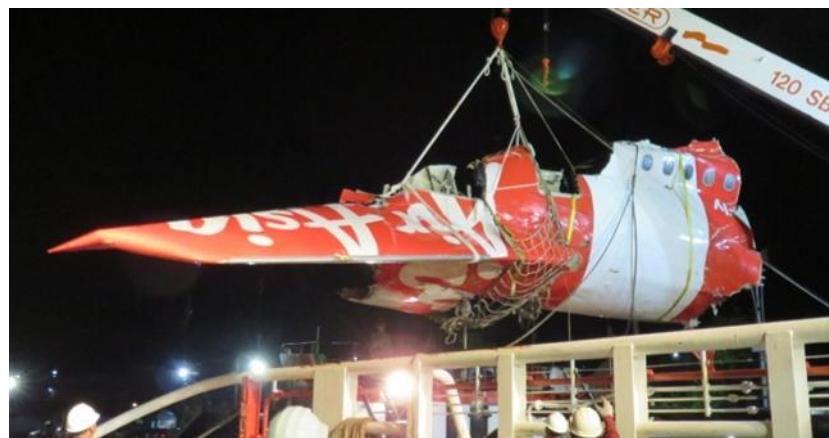
Figure 3: The recovered tail section being transferred to Kumai Harbour

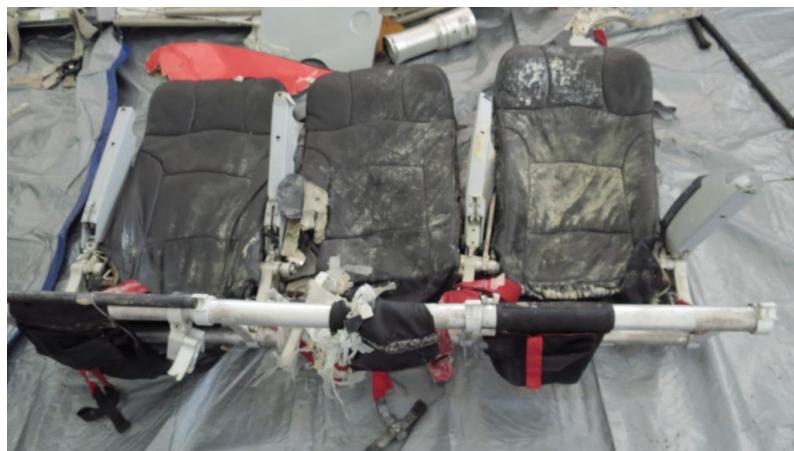
Figure 4: One section of passenger seats

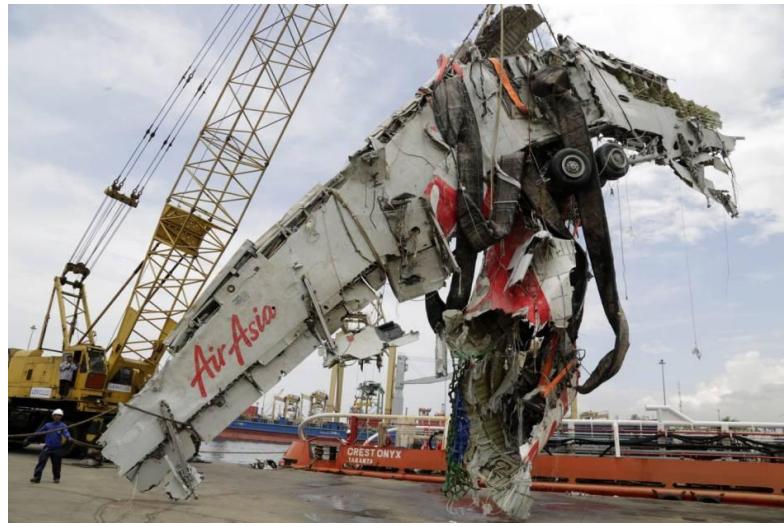
Figure 5: Centre fuselage section including the wings and main landing gears

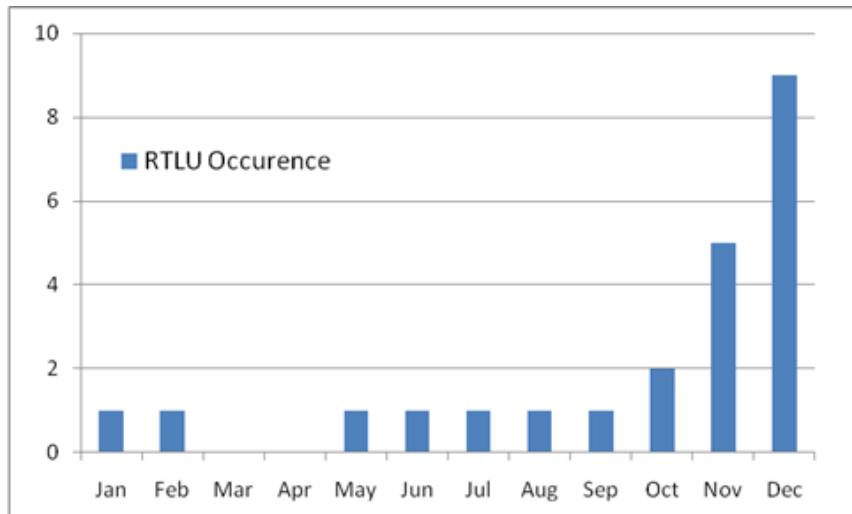
The numbers RTL1 occurrences as per PK-AXC 1 Year Maintenance Report were summarized in the following graph.

Figure 7: Numbers of the RTLUs Occurrences in 2014

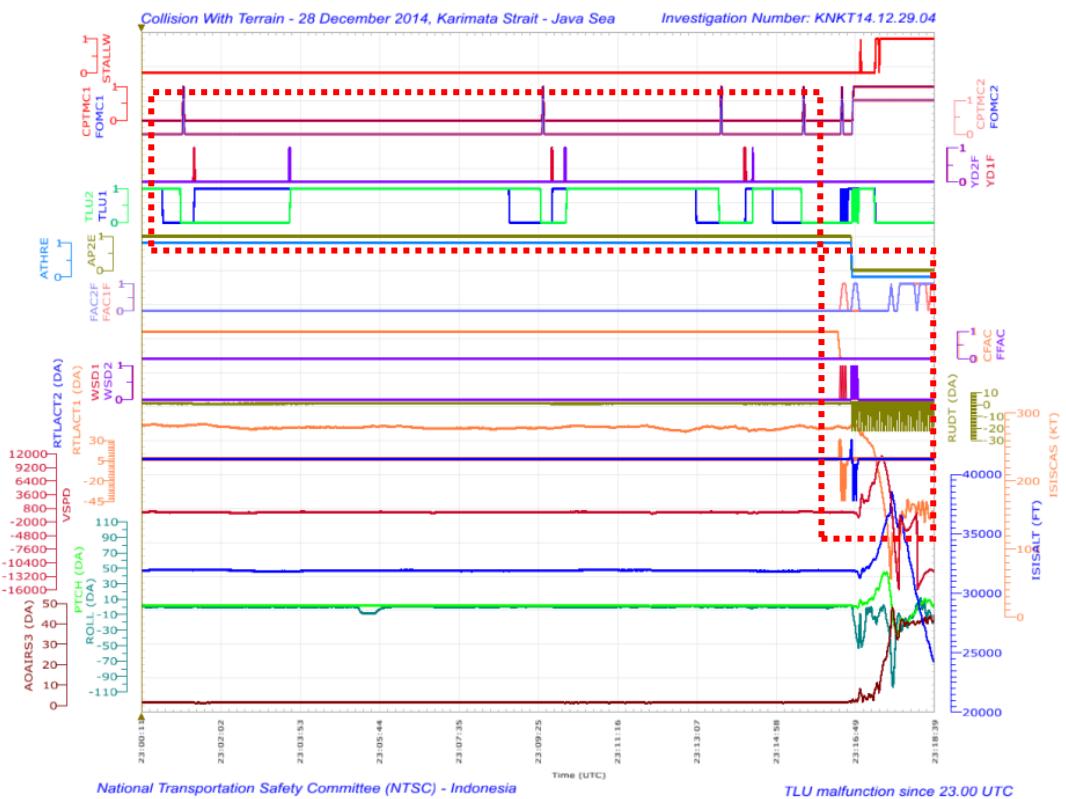
Figure 20: RTLUs problems and pilot actions

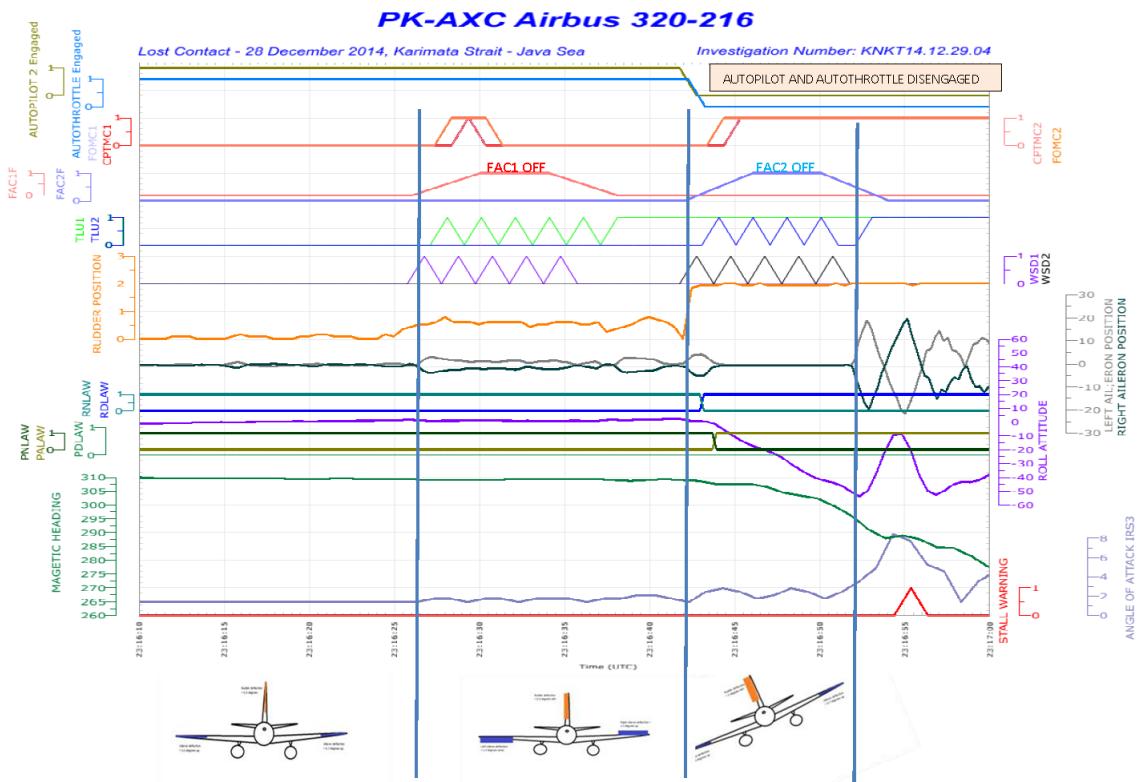
The fifth Master Caution at 2316:28 UTC was triggered by FAC 1 FAULT.

Figure 21: FDR parameters after the fifth Master Caution

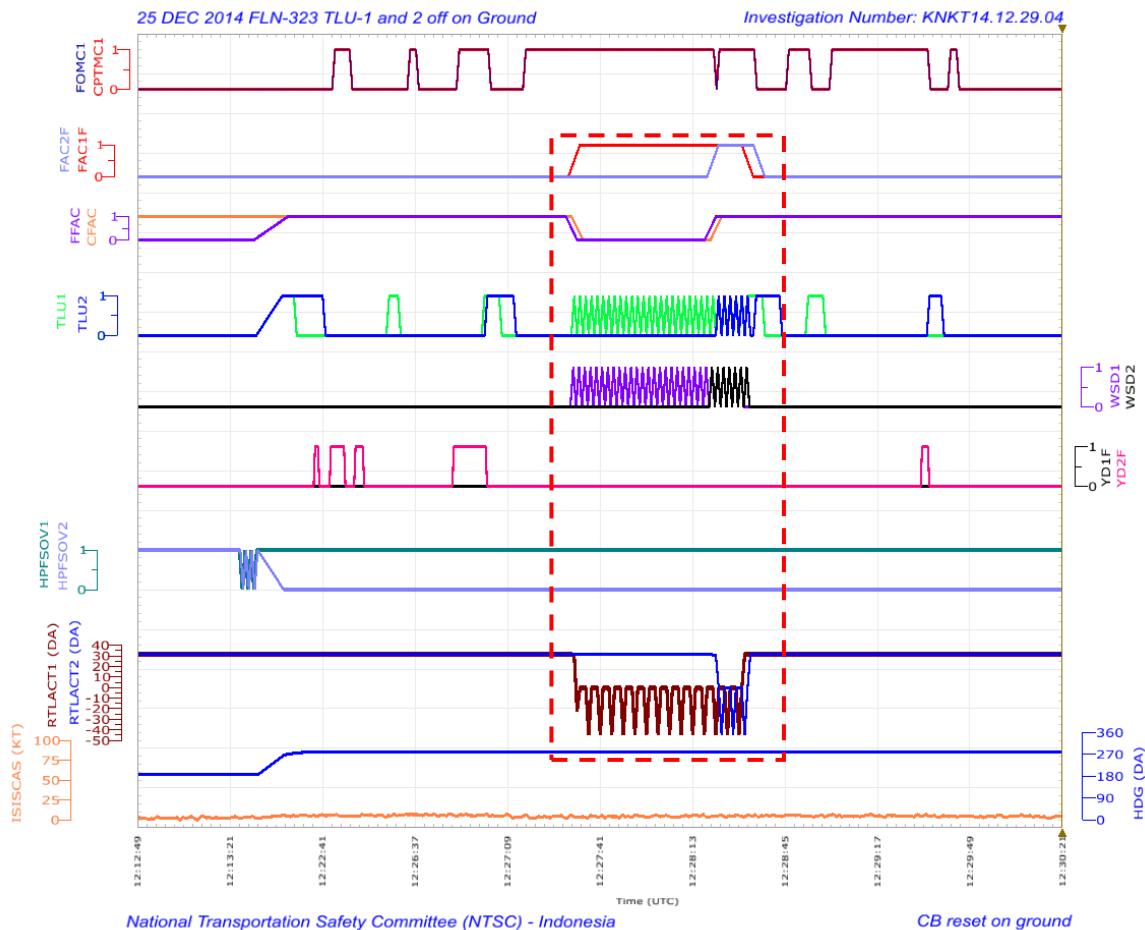
Figure 24: The FDR parameters of FAC fault followed by CB reset on the ground at 25 December 2014

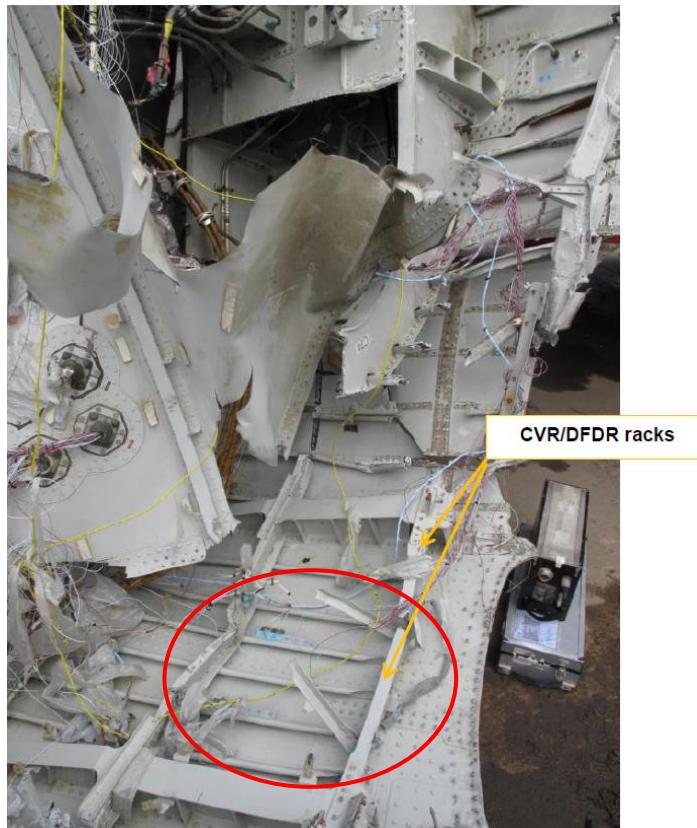
The distance between Tail to FDR and CVR was about 1500 m. The distance between FDR and CVR was about 135 m.

Figure 31: The FDR and CVR racks

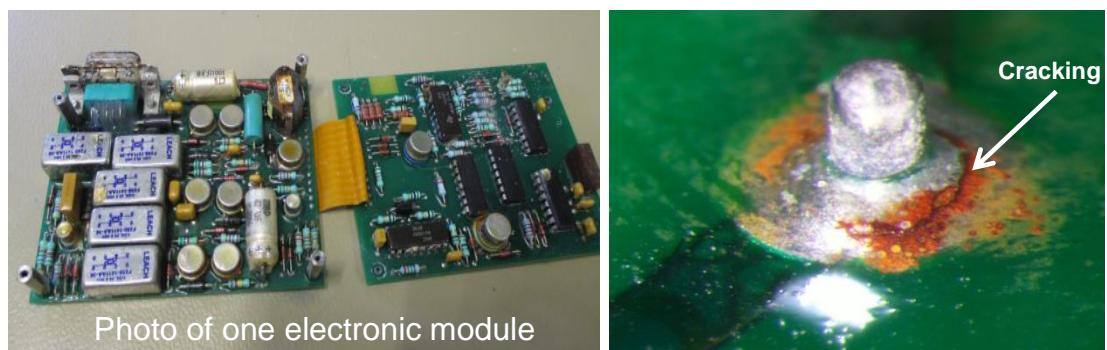
- The cracking of a solder joint of both channel A and B resulted in loss of electrical continuity and led to RTLUs failure.
- The existing maintenance data analysis led to unresolved repetitive faults occurring with shorter intervals. The same fault occurred 4 times during the flight.

Figure 35: Electronic Module of RTLUs
