AIRCRAFT ACCIDENT REPORT 3/2009

Air Accidents Investigation Branch

**Report on the serious incident to
Boeing 737-3Q8, registration G-THOF
on approach to Runway 26
Bournemouth Airport, Hampshire
on 23 September 2007**

Aircraft Accident Report No: 3/2009 (EW/C2007/09/12)

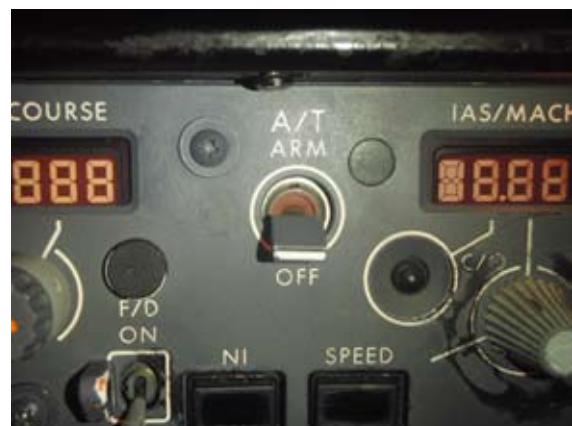
Figure 1
Autothrottle switch

selection controls. The servomechanisms (for left and right engines) are the interface between the system and the throttle operating linkages; thrust lever position is fed back via the synchros. The autothrottle is selected, or ARMED, by operating a two-position, solenoid-held paddle switch located on the left side on the glareshield panel (Figure 1). Once ARMED the switch is held in position unless disengaged. The autothrottle can be disengaged manually either by moving the paddle switch to the OFF position, or by pressing either of the push buttons that are located on the outboard end of each thrust lever. A green annunciator light beside the switch is illuminated when the autothrottle is engaged. Disengagement extinguishes the green light and illuminates a flashing red A/T P/RST autoflight status annunciator on the instrument panel (Figure 2). This can be cancelled by a second press on the buttons either side of the thrust levers, or by pressing the switch light itself.
