FINAL
KNKT.14.12.29.04

Aircraft Accident Investigation Report

**PT. Indonesia Air Asia
Airbus A320-216; PK-AXC
Karimata Strait
Coordinate 3°37'19"S - 109°42'41"E
Republic of Indonesia
28 December 2014**

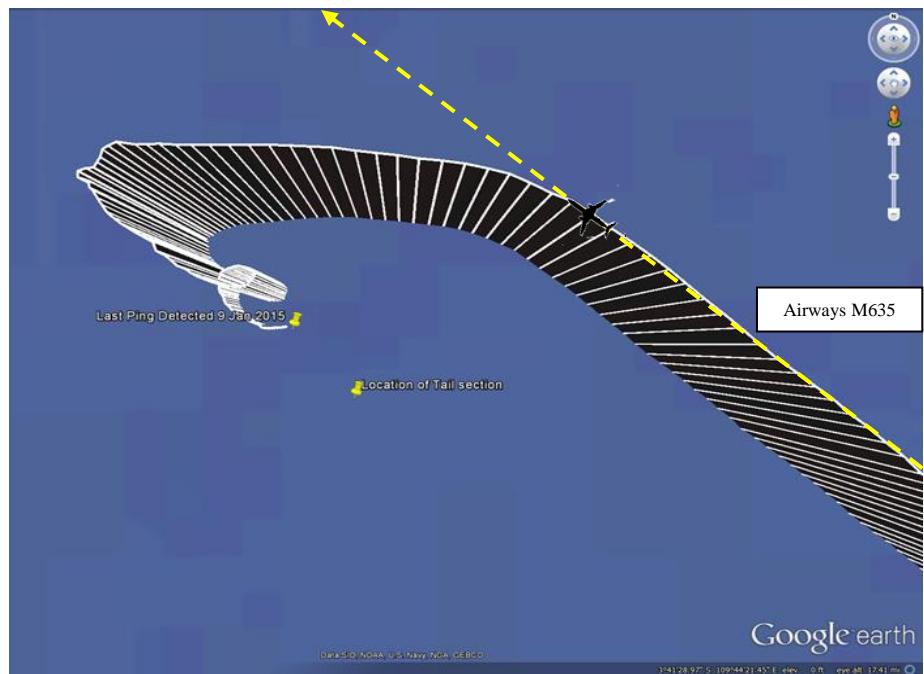
Figure 19: Flight path based on FDR data superimposed to the Google Earth

The FDR data showed that while the aircraft was cruising at an altitude of 32,000 feet in normal condition, the aircraft then deviated to the left from airway M635. The master caution triggered by both RTL problems activated 4 times. The fifth master caution was related to the FAC 1 FAULT activating. The sixth master caution was triggered by the FAC 1+2 FAULT and followed by the autopilot and auto-thrust disengaged and flight control law reverted from Normal Law to Alternate Law.

Subsequently the aircraft entered a steep turn and climb, eventually reaching high angle of attack, the stall warning activated and continued until the end of the recording. The FDR and CVR recording ended at 2320:35 UTC.

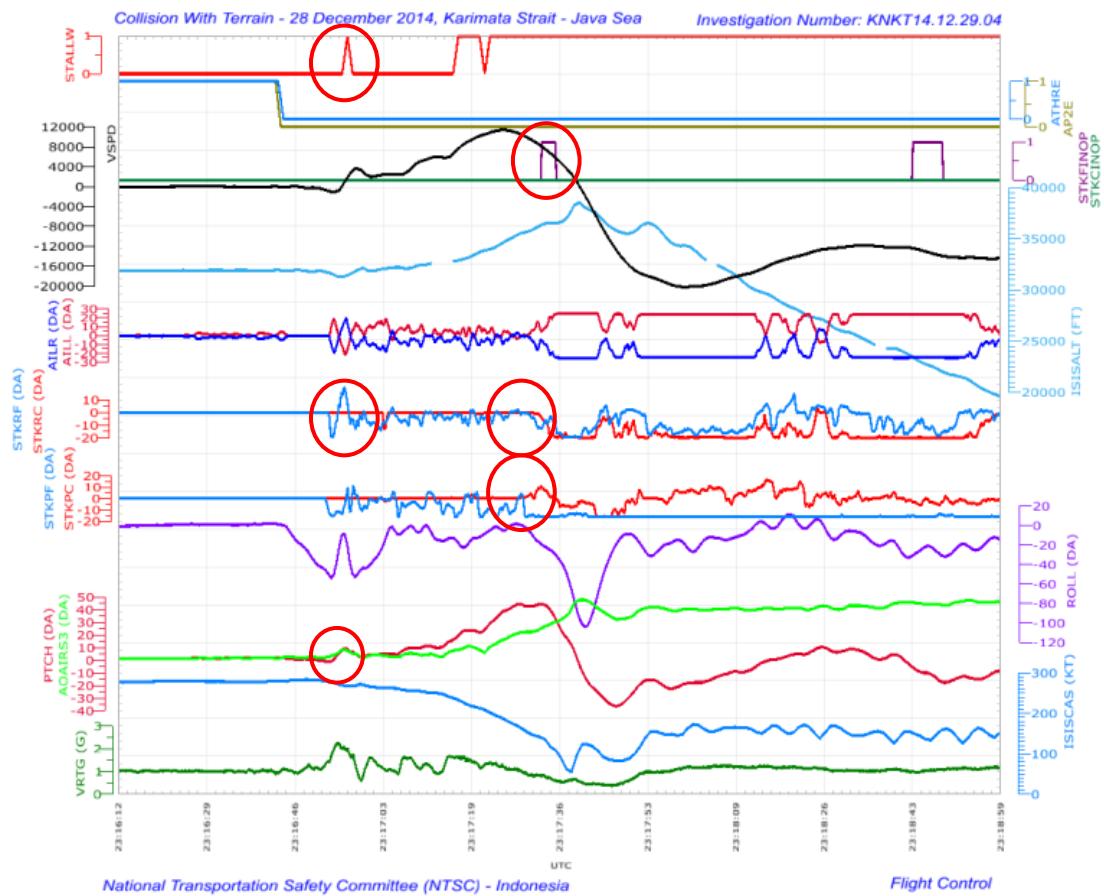
Figure 22: Pilots inputs on side stick

- Flight control law reverted from Normal Law to Alternate Law
 - Rudder deflected 2° and aileron deflection 0°.
 - The aircraft started to roll.
 - At 2316:54 UTC the FAC 2 was back to ON and all fluctuating parameters stopped. The autopilot and auto thrust remained disengaged. Flight control law remained in Alternate Law.

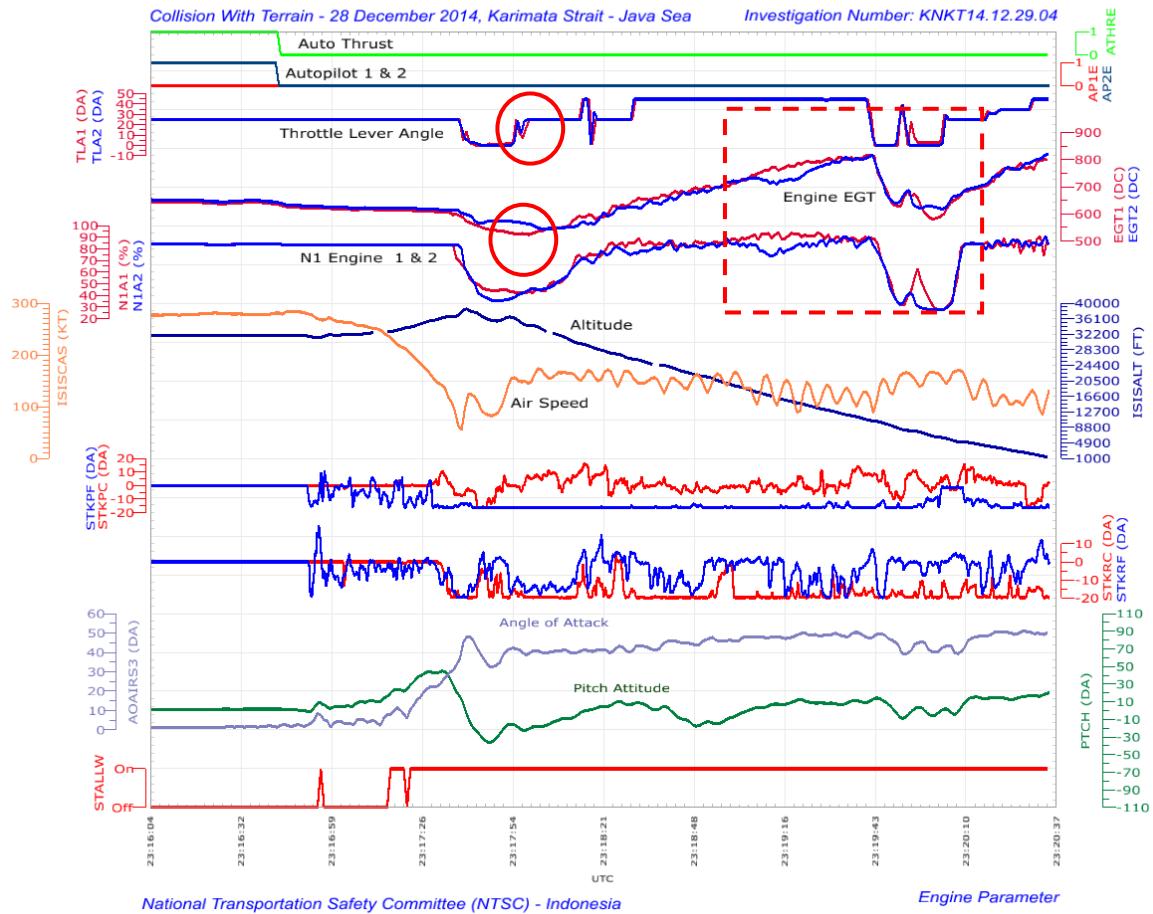
Figure 23: Thrust levers and side-sticks movement

- At 2317:41 UTC the aircraft reached the highest altitude of 38,500 feet (ISIS) and largest roll angle at 104° to the left. The aircraft then descended with a rate up to 20,000 feet per minute momentarily afterward the rate of descent was recorded at average of 12,000 feet per minute until the end of recording.

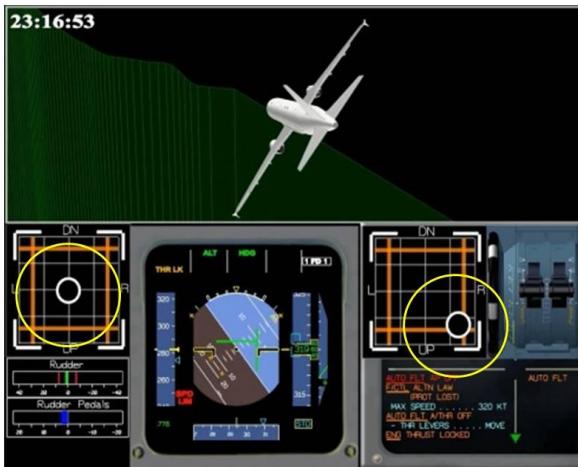
Figure 25: Aircraft rolled 54° to the left

Speed (knots)	277 (ISIS)	282 (CAS)
Alt (feet)	31952	
Rudder	2°	
Roll	54°	
Pitch	-1.1°	
AOA	3.5°	
VS(fpm)	-1088	
N1	83%	
EGT	622 °C	
Sidesticks	PIC P: 0° R: 0°	SIC P: -15° R: +19

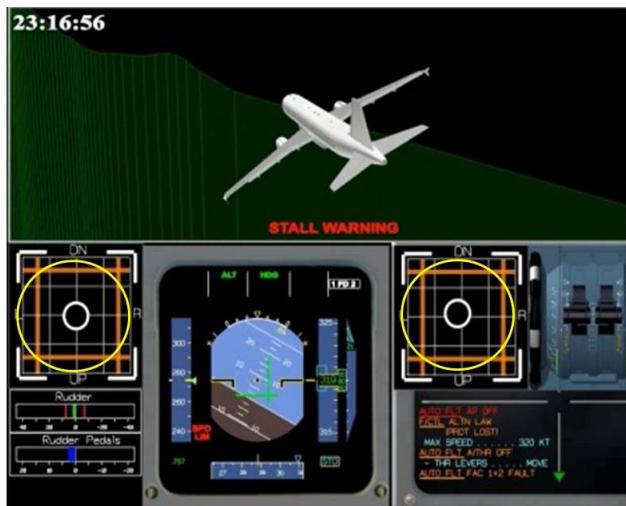
Figure 26: The first aural Stall warning activated

Speed (Knots)	268 (ISIS)	272 (CAS)
Altitude (Feet)	31980 (ISIS)	33900 (GPS)
Rudder	2°	
Roll	19.7°	
Pitch	9.5°	
AOA	8°	
VS (fpm)	2624	
N1	83%	
EGT	621 °C	
Side-sticks	PIC P: 0° R: 0°	SIC P: 7° R: +10°

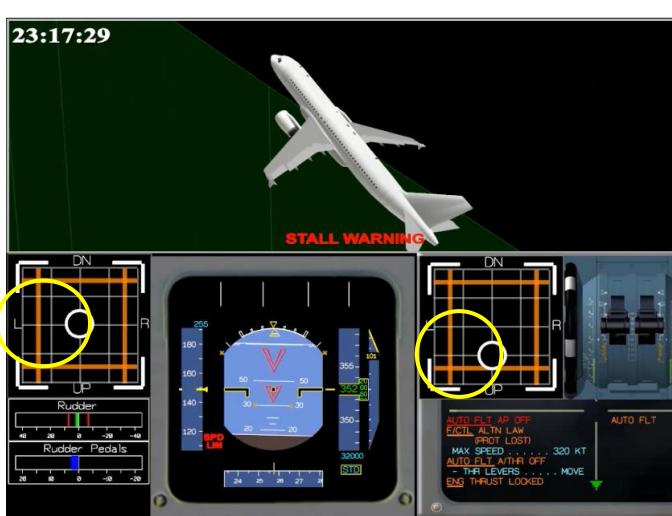
Figure 27: The aircraft attitude at the highest pitch angle

Speed (Knots)	159 (ISIS)	147 (CAS)
Alt (feet)	35568 (ISIS)	
Rudder	2°	
Roll	0.4°	
Pitch	44.3°	
AOA	21°	
VS (fpm)	10192	
N1	83%	
EGT	609 °C	
Sidesticks	PIC P: 0° R: 0°	SIC P: -15° R: -2°

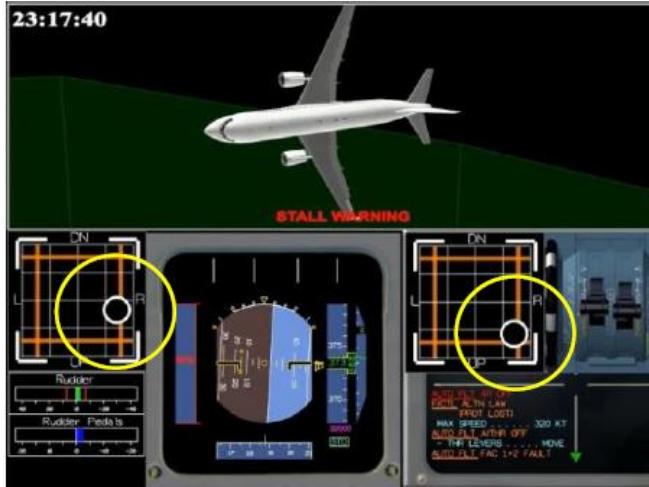
Figure 28: Aircraft in upset¹³situation

Conditions:		
Speed (knots)	118 (ISIS)	0 (CAS)
Alt (Feet)	37796 (ISIS)	
Rudder	-5°	
Roll	-104 °	
Pitch	-20.7°	
AOA	46°	
VS (fpm)	-4784	
N1	52%	
EGT	563 °C	
Sidesticks	<u>PIC</u> P: -4° R: -20°	<u>SIC</u> P: -16° R: -17°

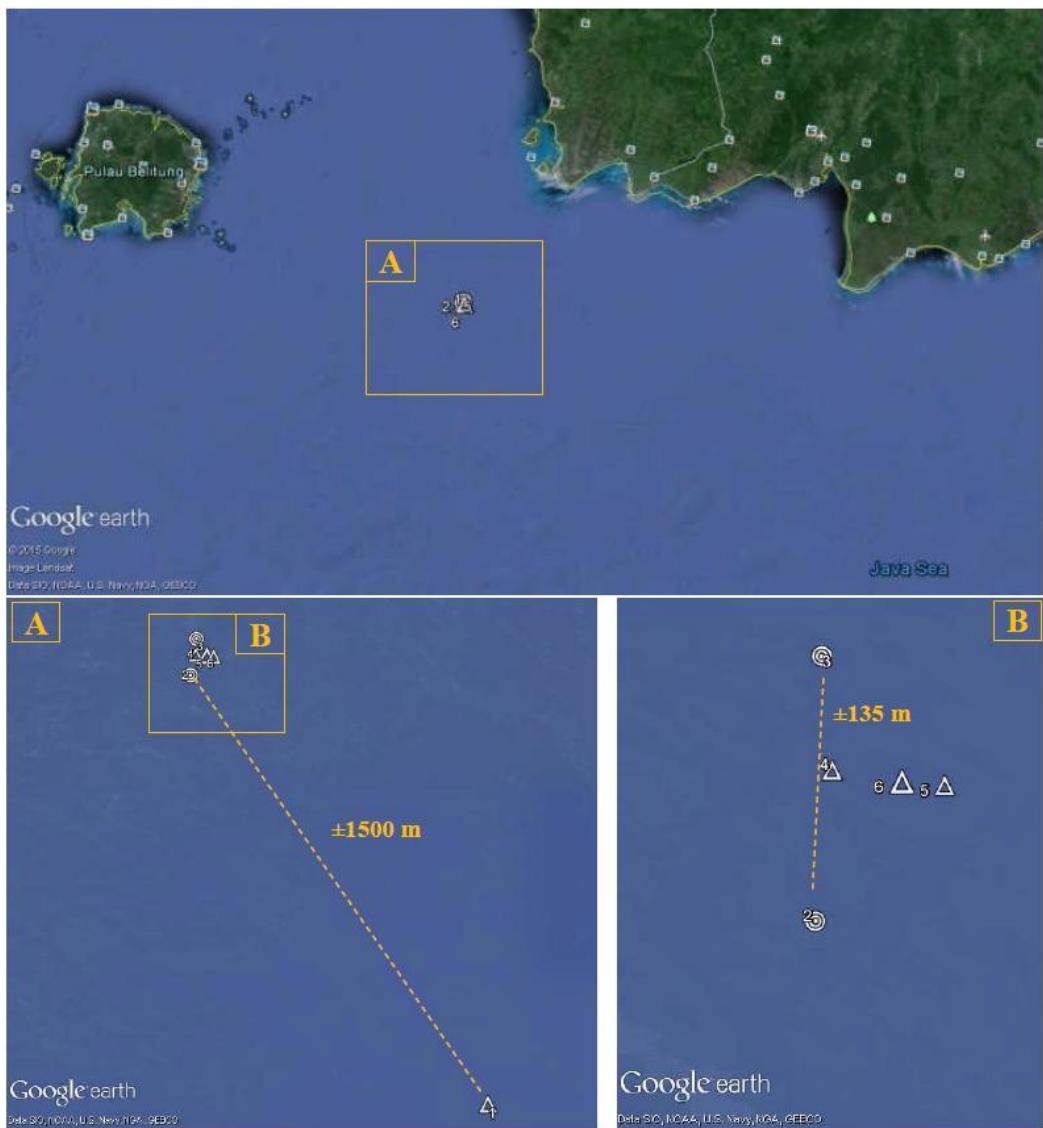
Figure 30: Wreckage Diagram superimposed on Google Map

On 13 January 2015 the major parts of the fuselage including both wings, main landing gears were identified on the sea bed at approximately 30 meters depth at coordinate 03°37'19.86"S - 109°42'42.36"E.

The tail section and fuselage were recovered and transferred to Kumai Harbour at Pangkalan Bun and afterward to Jakarta. The part sections recovered contain of vertical stabilizer and aft section of the fuselage up to section 73. The recorders were detached from its rack.

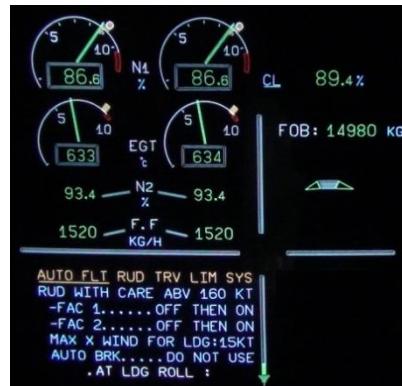
Figure 34: The ECAM messages after RTLUs 1 and 2 fault

As requested by the KNKT, BEA and Airbus performed the simulator session which referred to FDR data on the engineering simulator. The simulation intended to recreate ECAM messages appeared on the accident flight. The ECAM message during the RUD TRIM LIM SYS problem is presented in the following figure:
